MEMO

Subject: Beal Barren Pond Removal (Project# 114-560420) - Final

**BARREN POND REMOVAL
BEAL MTN MINE, MONTANA
TETRA TECH PROJECT 114-560420.200**

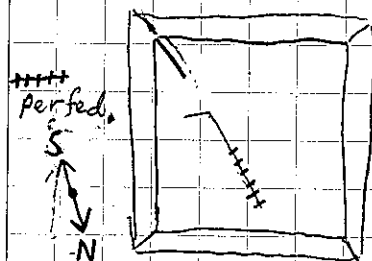
Found pipe ~10 ft further E of document
descriptions. Pipe was broken
before we excavated it. Chased back
North into pond. Identified first
20 ft is perforated as described w/
Rag stuck in end. Pipe is
4" HDPE. Buried ~18" below bottom
of pond as documented.
